OPERATION OF A FORCED CIRCULATION, HAYNES ALLOY NO. 25,
MERCURY LOOP TO STUDY CORROSION PRODUCT
SEPARATION TECHNIQUES

By David B. Cooper

Thompson Ramo Wooldridge Inc.

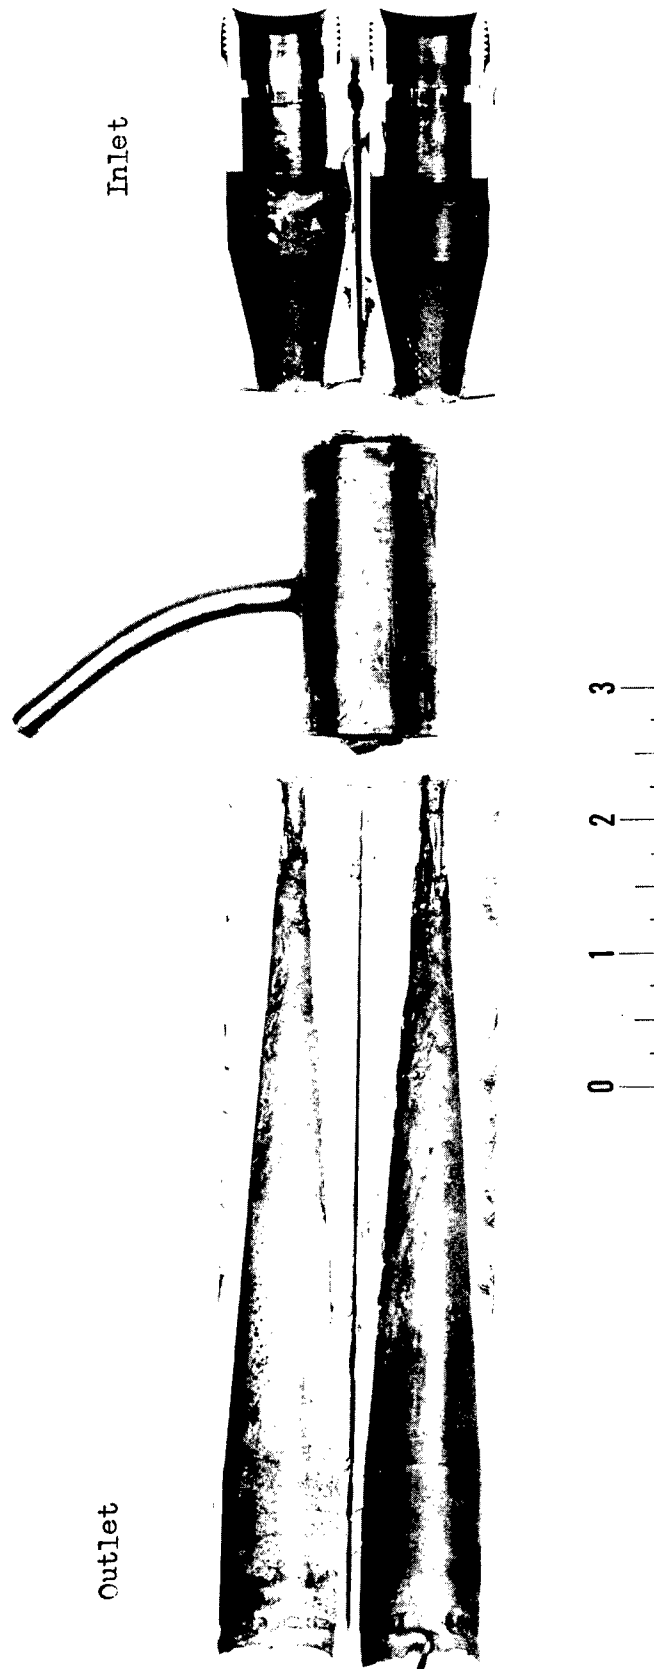
As shown in Figures 11 and 12, the Venturi was found to contain an amalgam which was located on the outlet side in the vicinity of the orifice. The pre-heater (Sections 10, 11, and 12) also contained an amalgam, as shown in Figure 13. Photographs of the boiler are shown in Figure 14. As seen here, the boiler inlet contained a small quantity of a dark deposit while the mid-section and outlet again contained an amalgam. The amalgam extended into the superheater inlet, as shown in Figure 15. From this point on, as the mercury was dried and superheated, the quantity of deposit decreased until the superheater outlet was reached, where an amalgam was again present. The vapor corrosion product separator outlet tube and the superheater mid-section were essentially free of deposit, Figure 15.

Figure 11. Deposition in Venturi.

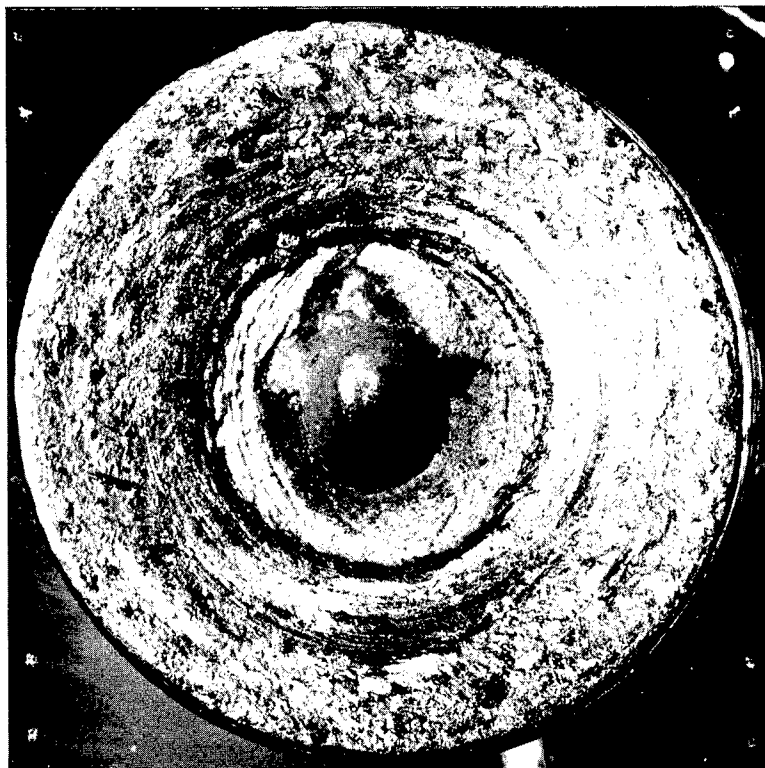
Figure 12. Outlet Side of Venturi Orifice Showing Amalgam Deposit.

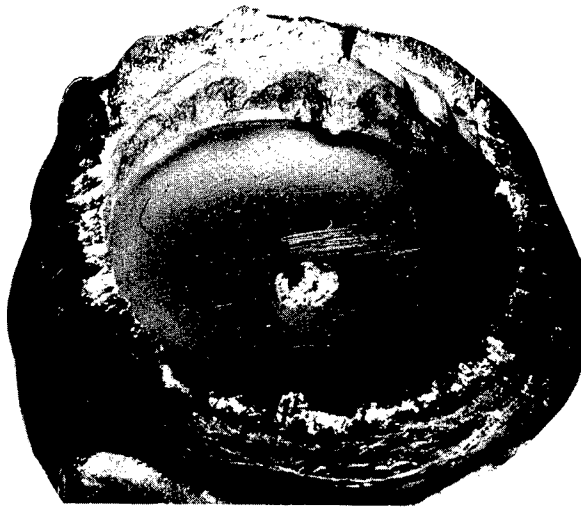
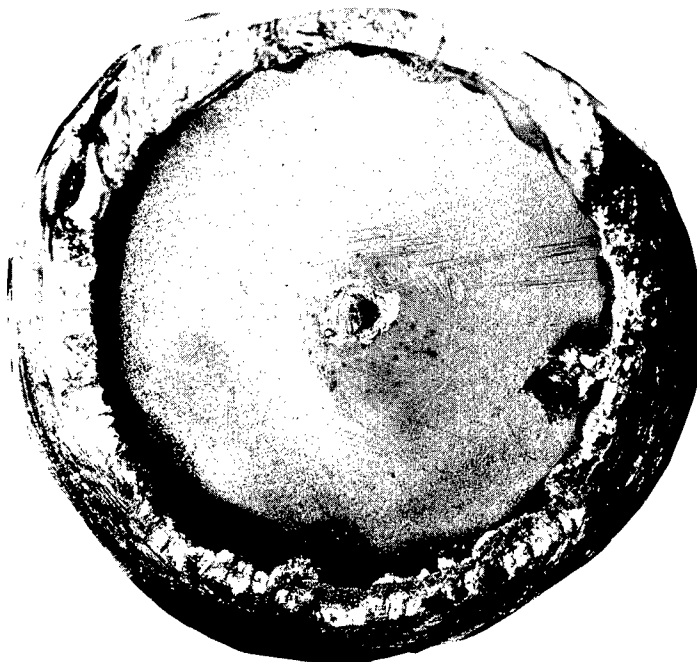
A hard deposit was found in the orifice and is shown in Figure 16. The deposit contained essentially no mercury and was blocking approximately 99.2 percent of the flow passage. The presence of this deposit accounts for the decrease in flow rate in the system during the final hours of operation. However, it is believed that the majority of this deposit was formed during the shut-down operation, since the change in flow rate did not reflect essentially complete blockage.

Figure 16. Deposit Found in Loop Orifice.

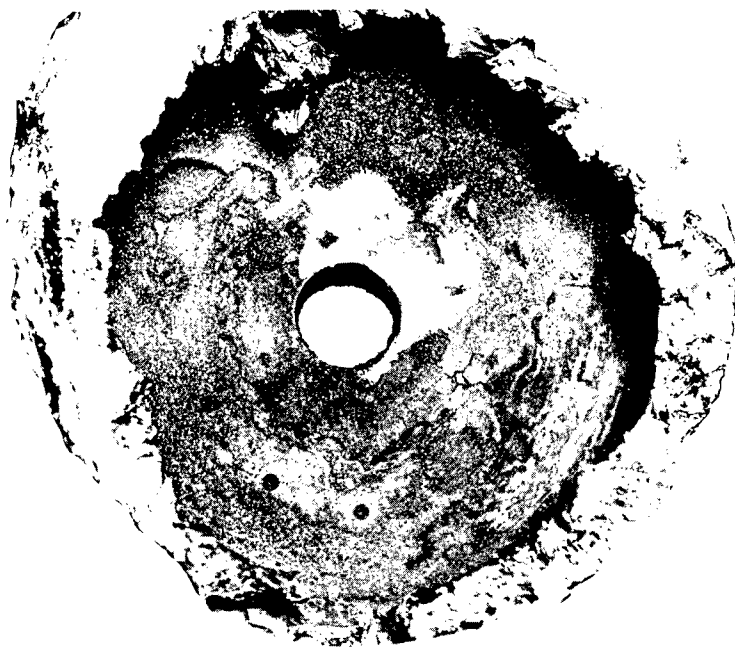
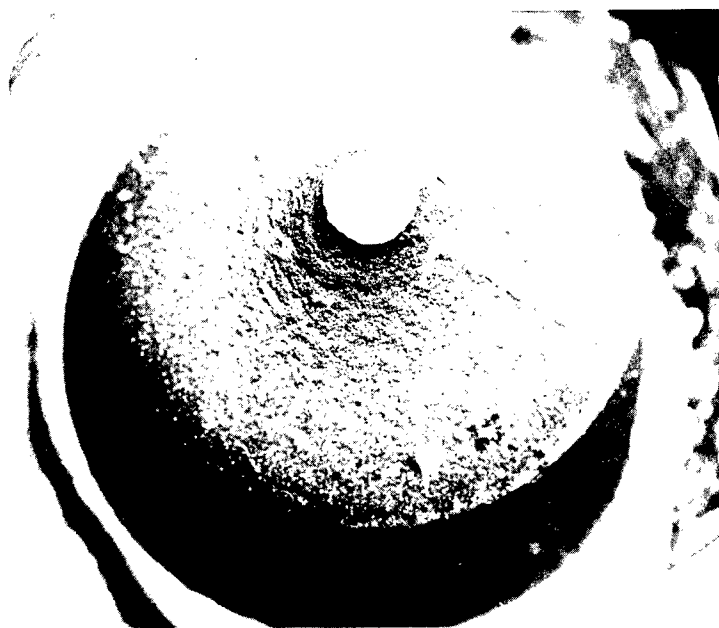
The nozzle was also observed to contain a deposit, as shown in Figure 17. Although there was a small amount of deposition on the inlet side, the majority of the deposit was found on the outlet.

Figure 17. Deposit Found in Loop Nozzle.

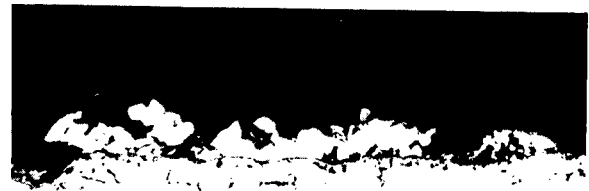
c) Section 8, TC 8 Boiler Inlet
(Layer Attack)

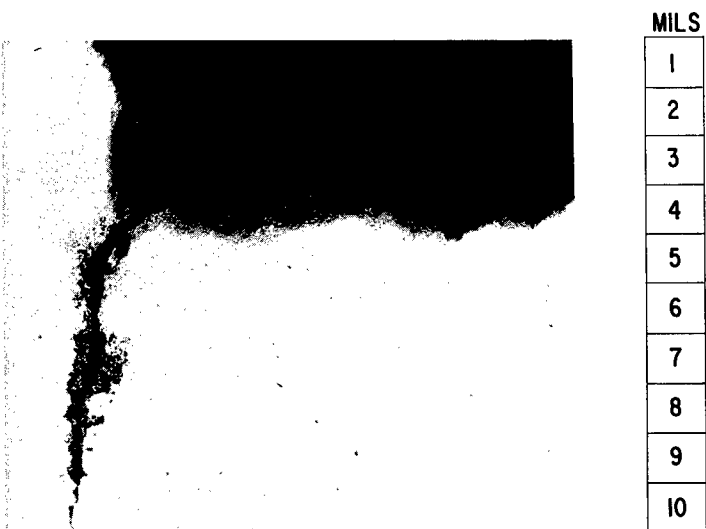
a) Section 5, TC 14
Weld; Superheater Inlet
(Layer Attack)

Haynes alloy No. 25 fusion welds appeared to be unattacked in all cases except in the vapor section (No. 5) of the boiler. Corrosion was present at the weld and in the crack, Figure 21a. Corrosion was manifested as a depleted layer.

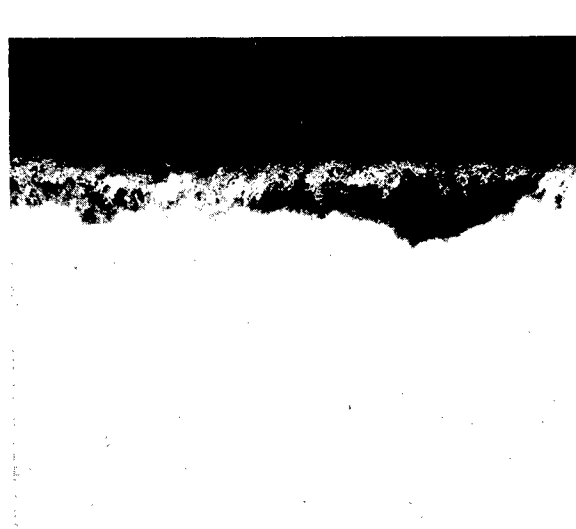
b) Section 5, TC 14
Superheater Inlet
(Layer Attack)

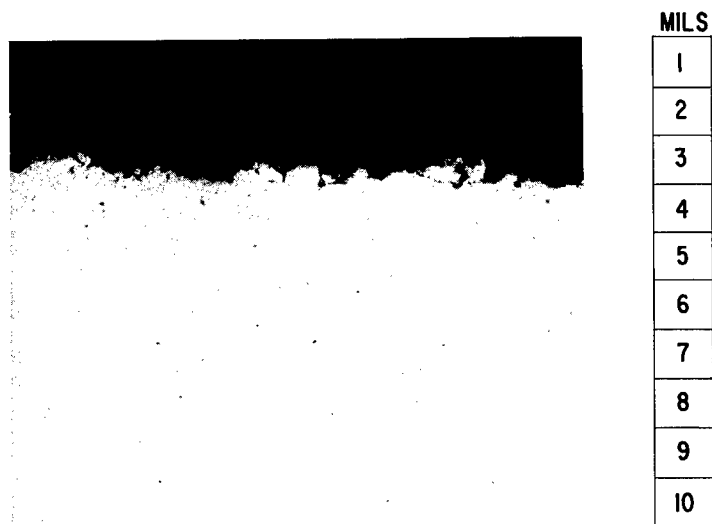
c) Section 5, TC 17
Superheater Inlet
(Crevice Attack)

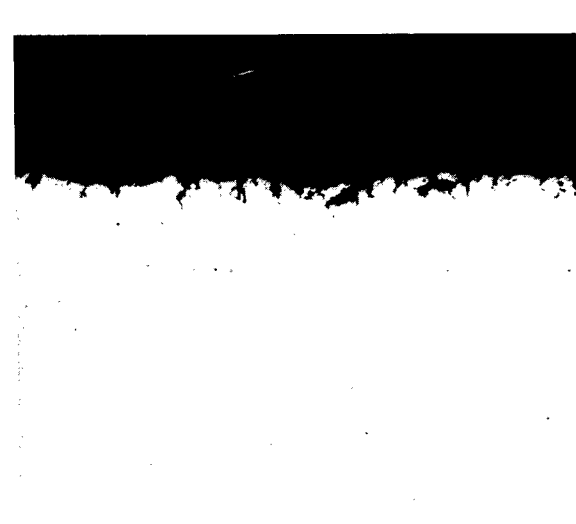
d) Vapor Corrosion Product
Separator Filter Tube
(Crevice and Intergranular Attack)

The vapor corrosion product separator was attacked to a depth of 1.9 mils in the 1130°F temperature zone. Corrosion was manifested as both intergranular and leached layer attack (see Figure 21d). Attack diminished to 1.1 mils penetration in the superheater mid-section as vapor quality improved, Figure 22a. Corrosion was of the crevice type. In the last quarter of the superheater (outlet), a substantial deposit was observed, Figure 22b. The maximum thickness of this deposit was seven mils. Swirl wire attack in the vapor portion of the loop generally was of the intergranular type and varied between 0.3 and 1.35 mils, Figures 23e and 24b and Table 3. Only the Haynes alloy No. 25 swirl wire in the vapor region contained cracks as contrasted to the lack of cracking in the liquid-contacted sections, Figure 24. The swirl wire was cold-worked as a result of swirl forming.

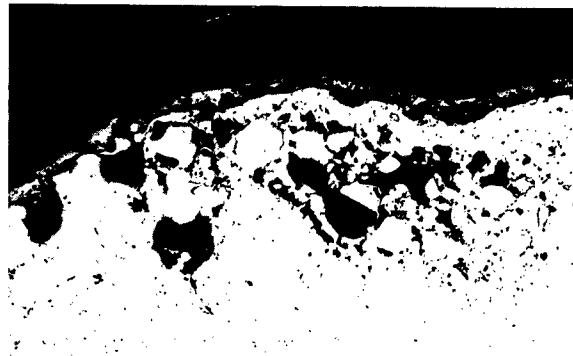
a) Section 2, TC 25
Superheater Mid-Section
(Crevice Attack)

b) Section 1, TC 27
Superheater Outlet
(Deposition)

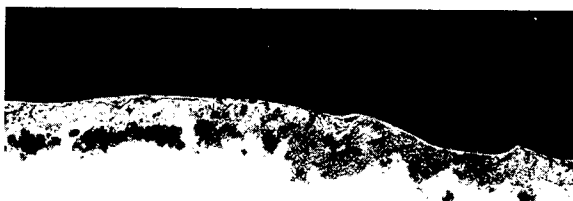
c) Section 8
Boiler Inlet
(Layer Attack)

d) Section 7
Boiler Mid-Section
(Layer and Intergranular Attack)

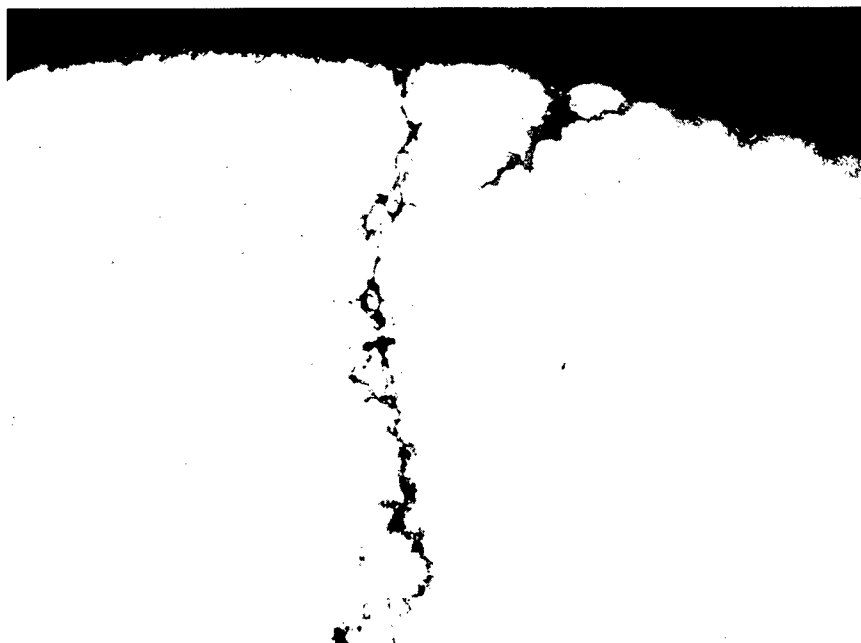
a) Section 6
Boiler Outlet
(Cracking and Layer
and Crevice Attack)

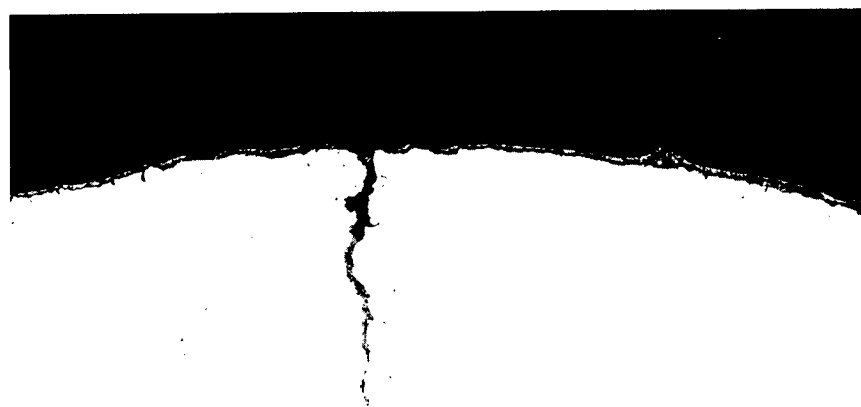
b) Section 2
Superheater Mid-Section
(Cracking and Intergranular Attack)

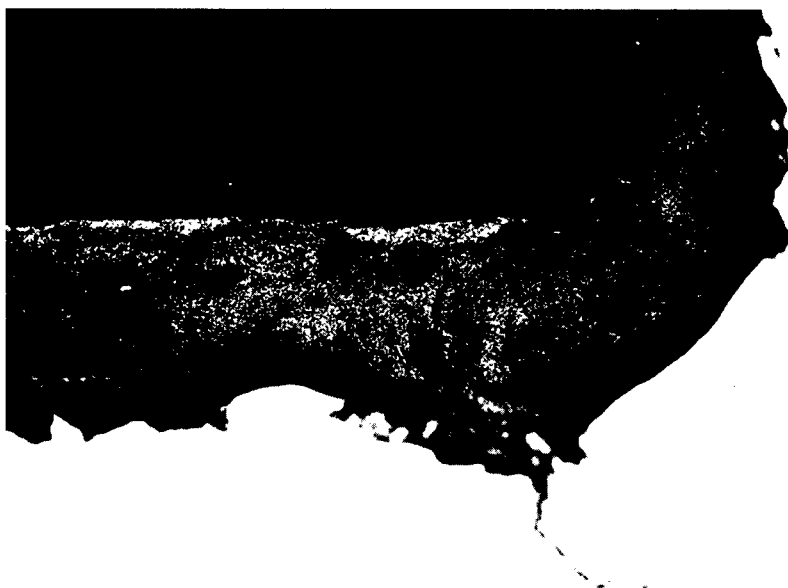
b) At Tube-Orifice Plate Junction

Figure 26. Cross-Section of Orifice on Inlet Side Showing Intergranular Attack Near Orifice Opening and a Leached Layer and Cracking at the Orifice Plate-Tube Junction. Magnification: 250X, Unetched.

Orifice corrosion was greatest on the inlet side near the wall and measured 7.3 mils in depth, Figure 25. Cracking was also observed at the orifice plate-tube wall junction, Figure 26b. Corrosion up to 1.1 mils in depth was also present on the orifice opening, Figure 26a. The corrosion was manifested as both layer and intergranular attack. The outlet side of the orifice contained deposits which adhered to the orifice wall. The attack was undoubtedly a result of mercury vapor condensation on the orifice plate, since immersion thermocouples recorded 796 and 867°F as the respective inlet and outlet temperatures. The severity of the attack could also be a result of erosive action by the condensing mercury vapor, which is not readily separable from corrosive attack.

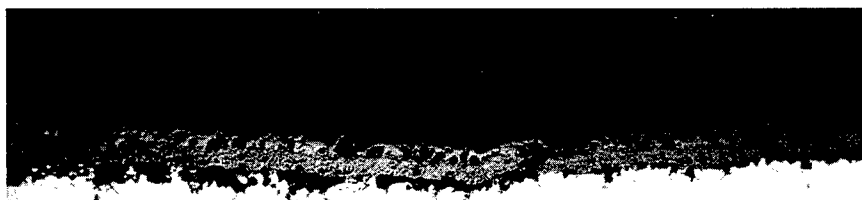
a) Inlet Side Oxidation

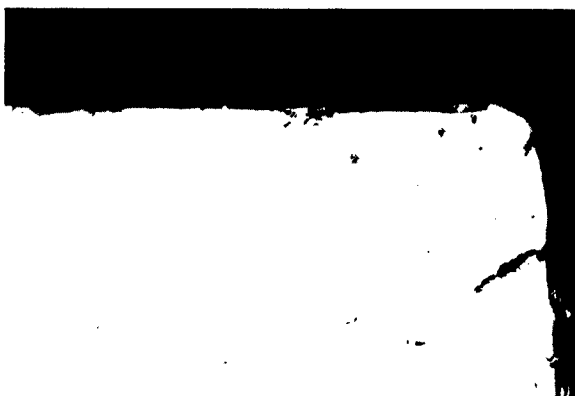
c) No. 3 Nivco 10
(Erosion and
Intergranular Attack)

d) No. 3 Nivco 10
(Deposition and
Intergranular Attack)

Corrosion was also evident in the eroded area. Erosion damage on PH15-7Mo in condition RH 950 (specimen No. 4) was less severe, 1.85 mils, Figure 28e. The increased resistance to erosion of specimen No. 4 over specimen No. 2 was probably the result of the greater hardness of specimen No. 4 (about 3 Rockwell C hardness units). Nivco 10 specimen No. 1 showed no signs of erosion. However, specimen No. 3 showed erosion up to 1.85 mils, Figure 28c.

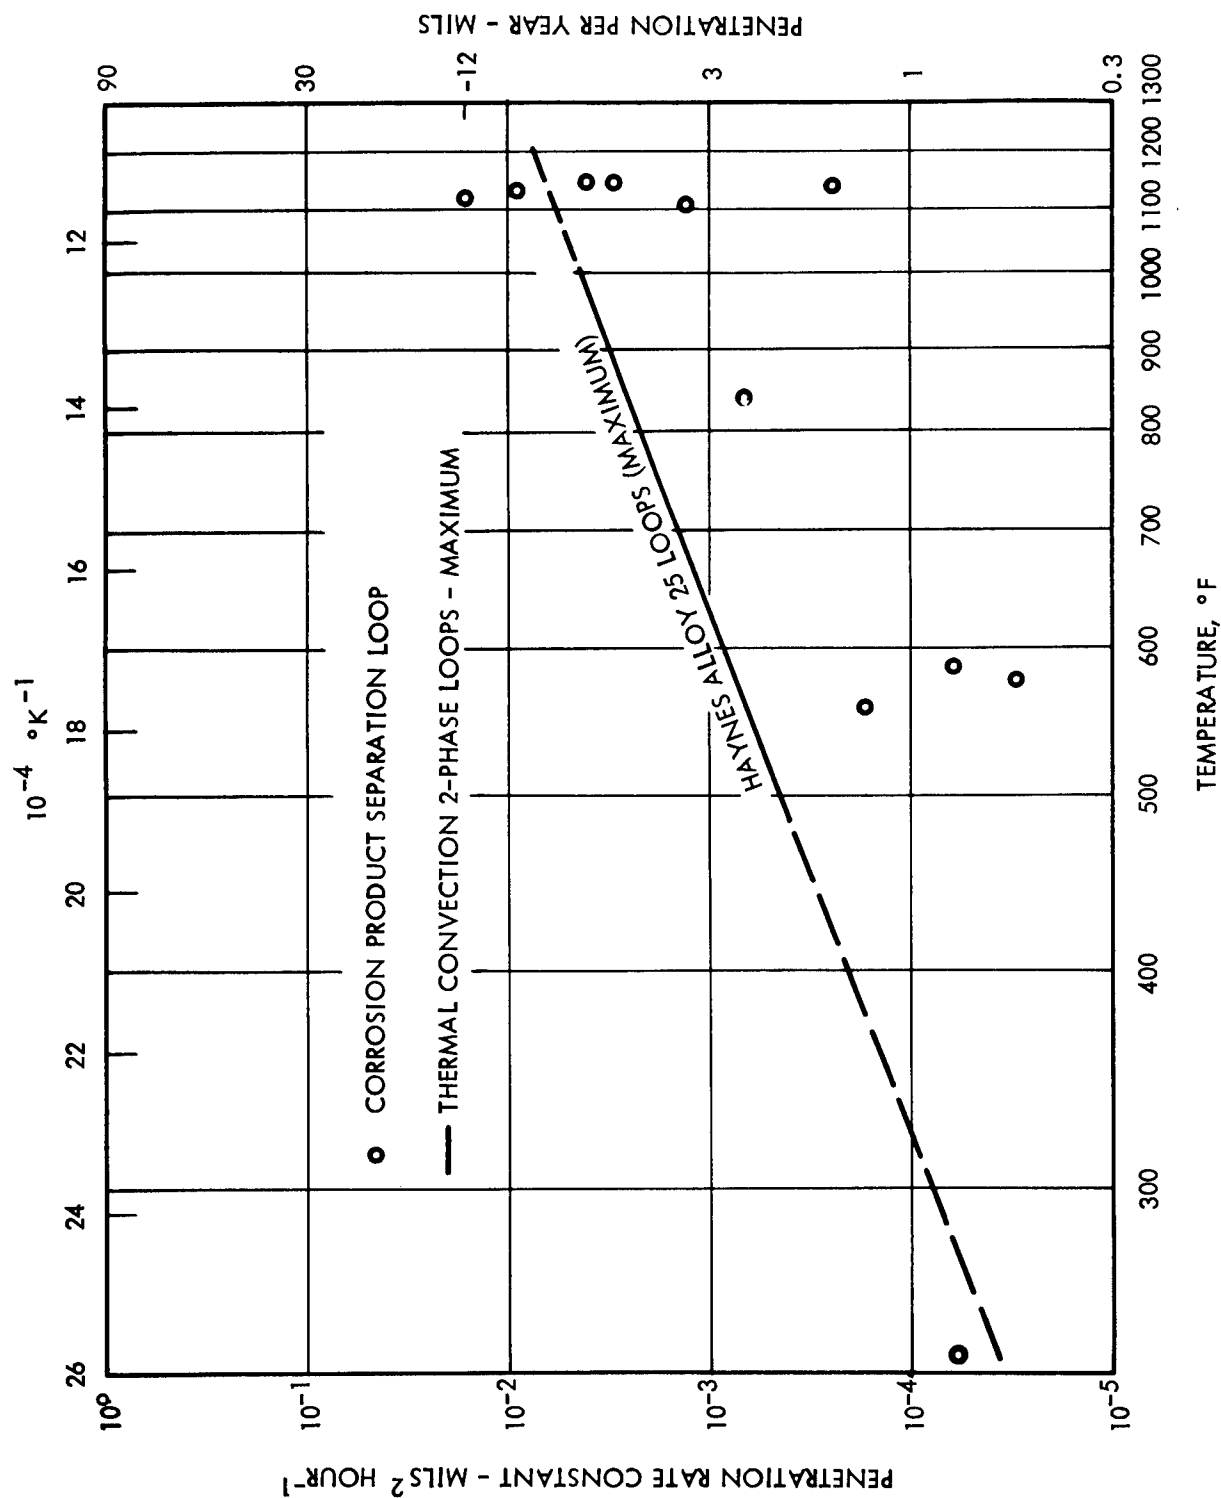
Corrosion for the Haynes alloy No. 25 forced circulation corrosion loop was compared with maximum penetration data obtained from thermal convection two-phase loops (4). Although the mercury mass flow rate was on the order of 10 to 40 pounds per hour greater in this forced circulation loop than in the natural circulation loops, the data compare favorably, as shown in Figure 30. The majority of the points fall below the maximum penetration observed for two-phase thermal convection mercury loops. The points which lie above this curve are the two isolated penetrations observed in the pre-heater outlet (10 mils at 1106°F) and the superheater inlet (7 mils at 1118°F).

FIGURE 30. COMPARISON OF HAYNES ALLOY NO. 25 MERCURY PENETRATION FROM CORROSION PRODUCT SEPARATION LOOP WITH THERMAL CONVECTION, TWO-PHASE LOOPS (4).

Extrapolation of Figure 30 shows that, under the conditions of this loop test, a maximum penetration of 12 mils might be expected in a Haynes alloy No. 25 system operated for a year's duration. The average penetration, however, could be expected to fall in the range of 2 to 6 mils per year.
